Fractographical Investigation of the Delamination under Fatigue Using Laser Confocal Electron Microscope

Rafiullah Khan^{*1}, Sakhi Jan¹, Sajjad Ahmad¹, Muhammad Amjad¹, Saeed Badshah¹, Mutahir Ahmad²
Department of Mechanical Engineering, International Islamic University Islamabad Pakistan
² NESCOM Pakistan

Abstract: In this paper fracture surface of the fatigue delamination have been investigated. Fatigue delamination tests were performed on the carbon/epoxy under different stress ratios. Samples were cut from the DCB specimens and analyzed in Laser Confocal Scanning Microscope. The analysis was used to measure the roughness values. Different fractographic features observed in the study are discussed.

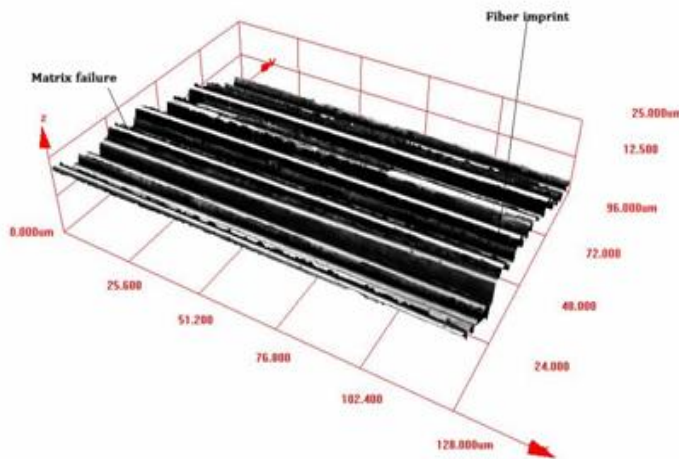
LCSM was used for taking images of the fracture surface. At same time the roughness values of the fracture surfaces were also calculated by the software in the computer system attached to the LCSM. The fracture surface was formed of fiber imprints, matrix failure between adjacent fibers and fiber breaks as shown in figure 2.

Figure 2: LCSM image of the fracture surface showing fiber imprints and matrix failure

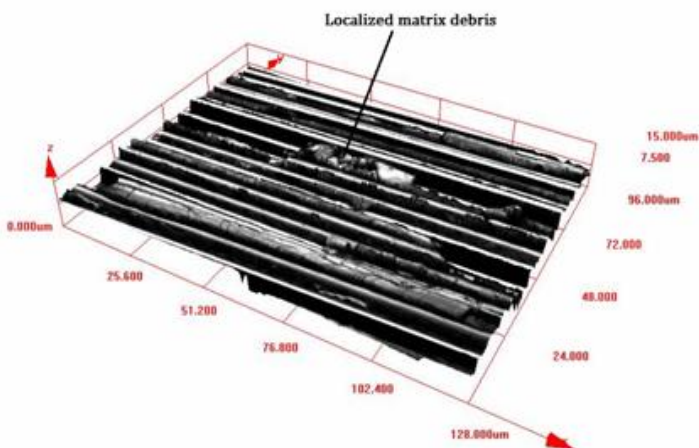
The presence of local matrix debris was observed as shown in figure 3. Such debris may be the result of local void or air traps during lay up. The voids act as accumulation places for the liquid matrix during curing process. Delamination growth under fatigue may be affected by these local debris.

Figure 3: Localized matrix debris

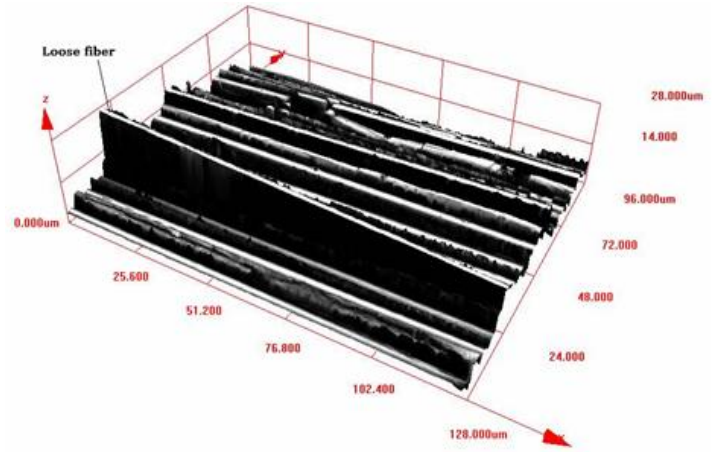
Loose fibers were observed on the fracture surfaces as shown in figure 4. These fibers results from the breakage of bridging fibers. Loose fibers enhance crack closure and acts like wedges during fatigue loading and reduce the delamination growth.

Figure 4: Loose fiber on the fracture surface

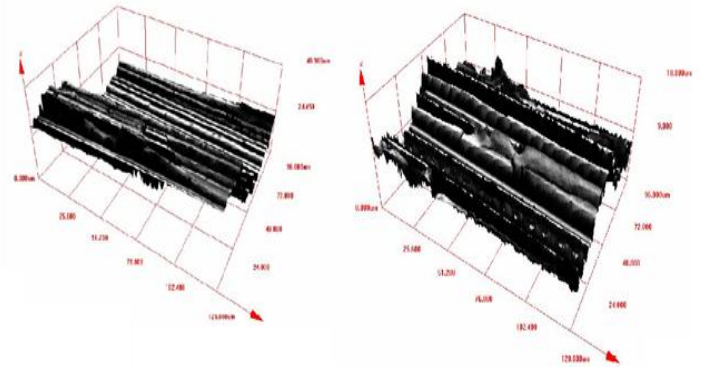
Surface topology is highly non-uniform at some places as shown in figure 5. This reflects the uneven delamination growth across the specimens. The crack closure due to roughness will be also different at different locations

Figure 5: Images showing high degree of non-uniformity of roughness distribution

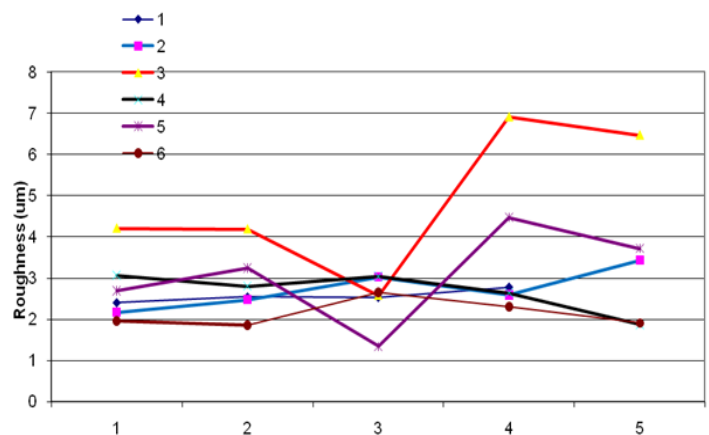
Average roughness values for different specimens across sample size are shown in figure 6. The mean roughness value is around 2.5 um. Maximum roughness value occurs in few observations and it was equal to 6.9 um.

Figure 6: Average roughness values across sample size
